Product Comparison

Fiberglass Reinforced Panels vs. Multiwall Polycarbonate Panels

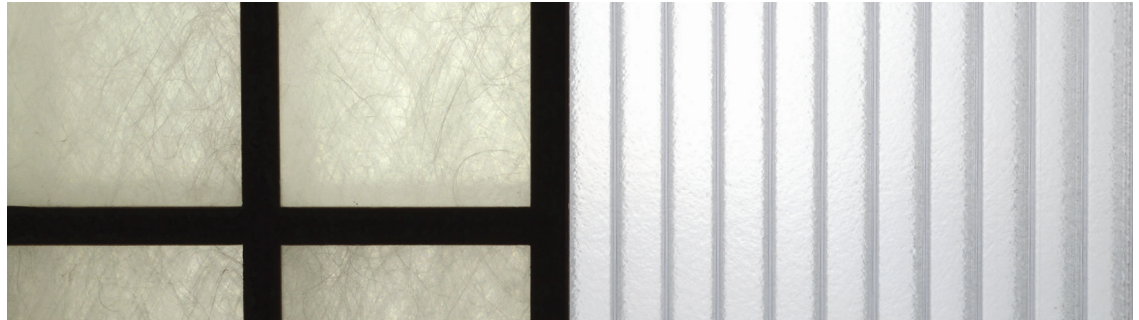
Fiberglass sandwich panel photographed side-by-side with a Wasco 40mm multiwall polycarbonate panel.
